**Flood Control Project Maintenance
Levee Inspections**
LMA District Cover Sheet
Spring 2017 Levee Inspection Results

Sutter Maintenance Yard Maintenance Area 0007

Levee Inspection Report By Mile - Spring 2017

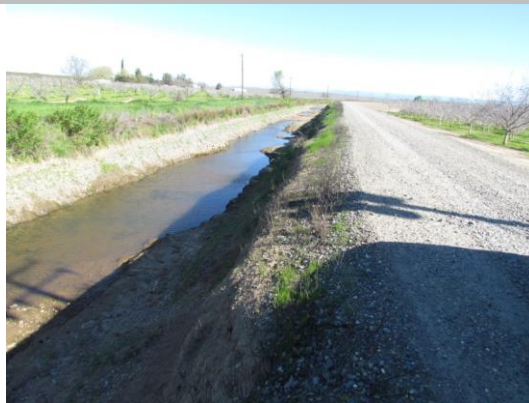
Photo 2 of 2 : SP_2017_MA0007_200_42_20170316_00004.jpg

This photo was taken from the levee crown facing north looking at the erosion along the landward levee slope due to an agricultural ditch. Spring 2014.

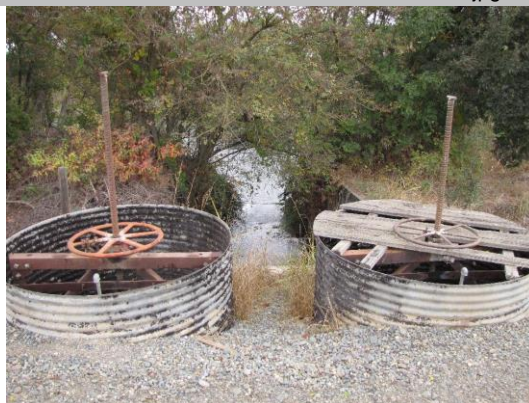
Photo 2 of 3 : UCIP_SP_2017_47836_65813.jpg

FS_ID:47836
DS_ID:16926
EP_NO: N/A
Repair Type: Non-Urgent
Crossing Status: Found
UCIP Comments: 5/16/2016 Feather River West Levee Improvement Project--Levee currently under construction.6/10/2015 Debris still present in risers and pipes were not replaced with the SBFCA project.12/29/2014 Same as last inspection.5/19/2014 Same as last inspection.11/6/2013 Same as last inspection.5/13/2013 SBFCA project recommends replacing in accordance with title 23.5/7/2013 Same debris issue as last inspection. Recommend repairing top cover to prevent falls. Wheel to open gate chained and locked so could not verify gate operation.10/31/2012 Debris inside riser could prevent slide gate from closing. This crossing was listed in the USACE Periodic Inspections as ID# USACE_CESPK_MA07_2010_a_0060 however, no issues noted. FIELD_STRUCT_DESC: 1 of 2: 60-inch drainage pipe through the levee, 12.5 feet below the crown. Slide gates in 78-inch corrugated metal pipe (CMP) wells on the waterside (WS) slope. Concrete bulkhead on both WS and landside (LS) ends. Reinforced concrete spillway an the WS end. [Additional Reference(s): DWR Levee Log, 2005. USACE Sacramento O&M Manual 152, March 1957 (Station 1+90)]

78-inch CMP risers located on WS slope. Upstream riser (far left) missing riser cover. Reinforced concrete spillway also located on WS end.

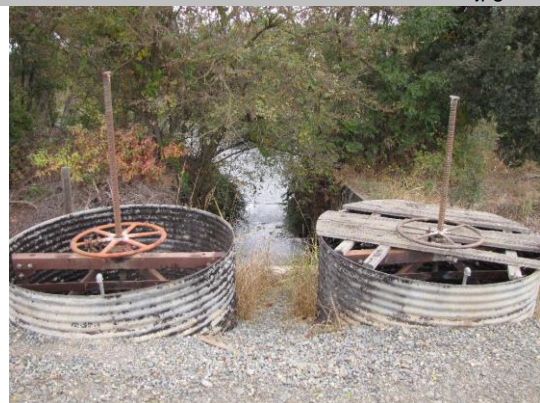
Photo 2 of 3 : UCIP_SP_2017_47837_65819.jpg

FS_ID:47837
 DS_ID:17011
 EP_NO: N/A
 Repair Type: Non-Urgent
 Crossing Status: Found
 UCIP Comments: 5/16/2016 Feather River West Levee Improvement Project--Levee currently under construction.6/10/2015 Debris still present inside riser and pipe was not replaced with the SBFCA project.12/29/2014 Same as last inspection.5/19/2014 Same as last inspection.11/6/2013 Same as last inspection.5/13/2013 SBFCA project recommends replacing in accordance with title 23.5/7/2013 Same as last inspection. Recommend constructing cover to prevent falls. Wheel to operate gate chained and locked so gate operation could not be verified.10/31/2012 no cover; debris inside riser could prevent slide gate from closing. This crossing was listed in the USACE Periodic Inspections as ID# USACE_CESPK_MA07_2010_a_0060 however, no issues noted. FIELD_STRUCT_DESC: 2 of 2: 60-inch drainage pipe through the levee, 12.5 feet below the crown. Slide gates in 78-inch corrugated metal pipe (CMP) wells on the waterside (WS) slope. Concrete bulkhead on both WS and landside (LS) ends. Reinforced concrete spillway on the WS end. [Additional Reference(s): DWR Levee Log, 2005. USACE Sacramento O&M Manual 152, March 1957 (Station 1+90)]

78-inch CMP risers located on WS slope. Upstream riser (far left) missing riser cover. Reinforced concrete spillway also located on WS end.

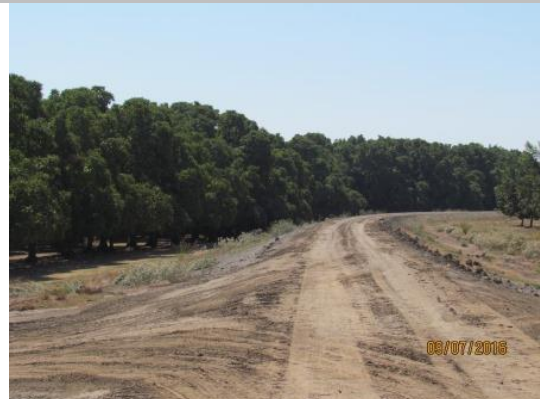
Photo 1 of 2 : SP_2017_MA0007_200_62_20170316_00013.jpg

LM Start	1.82	Rating **	A	Issue No.	62
LM End	2.53	Issue Type +	Ma	Location *	CR
Category	Earthen Levee			GPS Latitude/Longitude	
				Start	End
Item	Crown Surface / Depressions / Rutting			39.335774 °	39.345322 °
				-121.633888 °	-121.629603 °
DWR ID	DWR_MA0007_01_f_2016_62				
Comment Code					
C1 : Add appropriate material and re-grade the levee to bring the crown above the design elevation.					
Inspector Comment					
This section of levee has been brought back to design elevation and the aggregate base placed.

View of levee that has been brought back to design elevation but still needs the aggregate base placed. Looking downstream. Fall 2016.

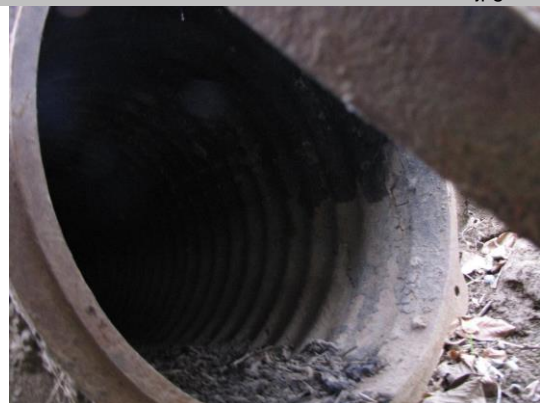
Photo 3 of 3 : UCIP_SP_2017_47975_65826.jpg

Crossing appears to be tar coated inside, unable to confirm damage to wall.

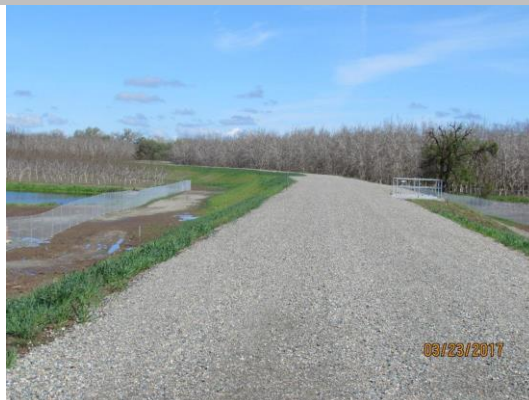
Photo 1 of 2 : SP_2017_MA0007_200_61_20170327_00121.jpg

LM Start	2.53	Rating **	A/W	Issue No.	61
LM End	3.33	Issue Type +	Ma	Location *	CR
Category	Earthen Levee			GPS Latitude/Longitude	
				Start	End
Item	Crown Surface / Depressions / Rutting			39.345322 °	39.354627 °
				-121.629604 °	-121.635530 °
DWR ID	DWR_MA0007_01_f_2016_61				
Comment Code					
C2 : Repair depressions or ruts in the crown or slope.					
Inspector Comment					
This section of levee is back to design elevation and crown rocked.

View of the levee that has been brought back to design elevation and rocked, looking upstream. Spring 2017.

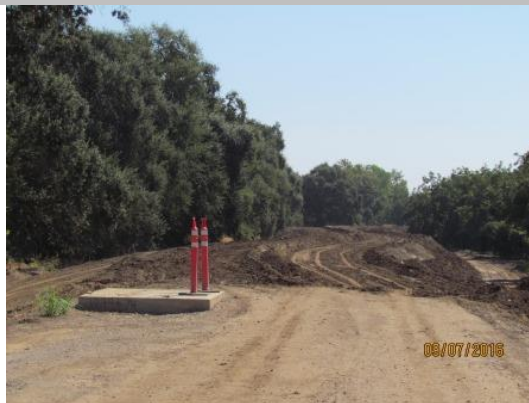
Photo 2 of 2 : SP_2017_MA0007_200_61_20170316_00012.jpg

View of the levee that is currently under construction and has been degraded and is being brought back to design elevation, looking downstream. Fall 2016.

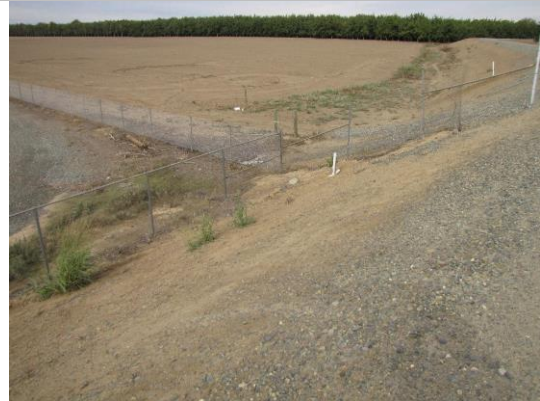
Photo 3 of 3 : UCIP_SP_2017_47937_65862.jpg

View of LS slope at crossing alignment projection. No crossing or appurtances visible on LS.

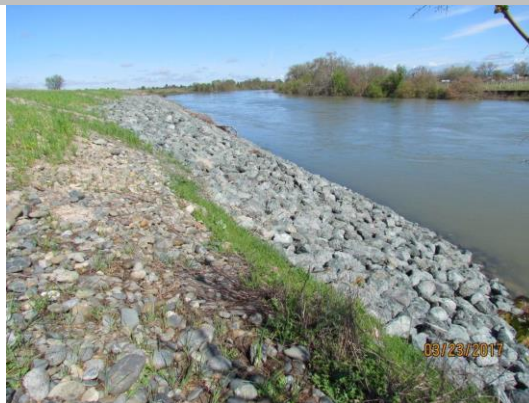
Photo 1 of 1 : SP_2017_MA0007_200_6_20170327_00123.jpg

Erosion repair photo Spring 2017.

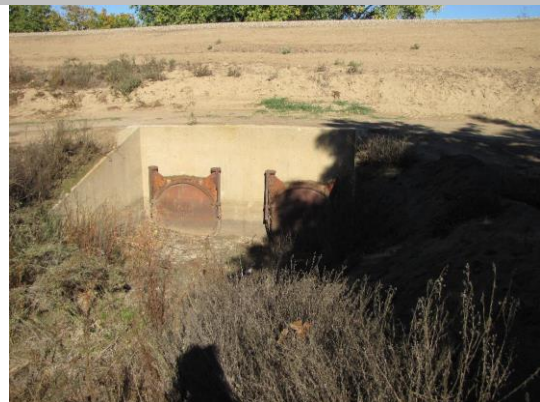
Photo 2 of 3 : UCIP_SP_2017_48005_65905.jpg

View of headwall structure on WS. Sediment built up

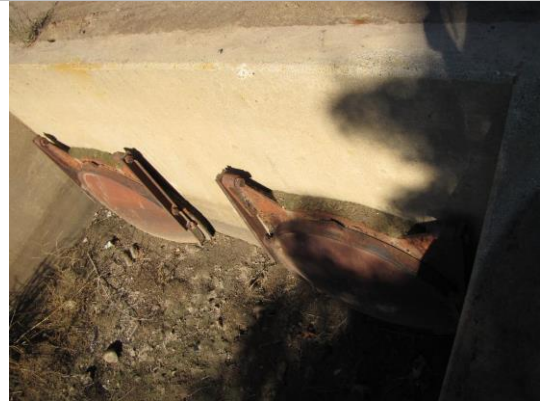
Photo 3 of 3 : UCIP_SP_2017_48005_65908.jpg

Sediment blocking gates on WS.

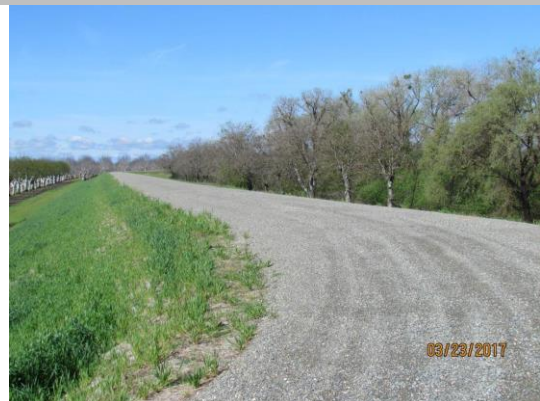
Photo 1 of 2 : SP_2017_MA0007_200_54_20170327_00124.jpg

View of this portion of the levee that has been degraded and is being brought back to design elevation and rocked. Spring 2017.

C2 : Repair depressions or ruts in the crown or slope.

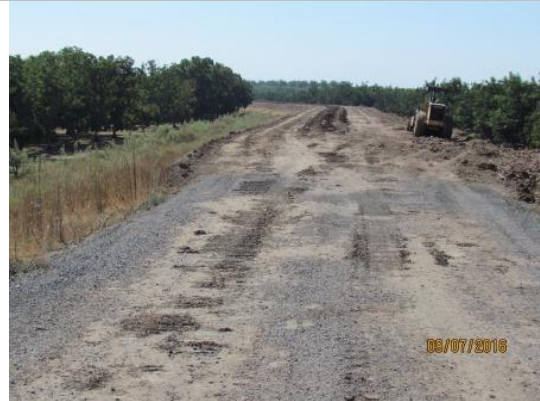
Photo 2 of 2 : SP_2017_MA0007_200_54_20170316_00010.jpg

View of this portion of the levee that is currently under construction that has been degraded and is being brought back to design elevation. Fall 2016.

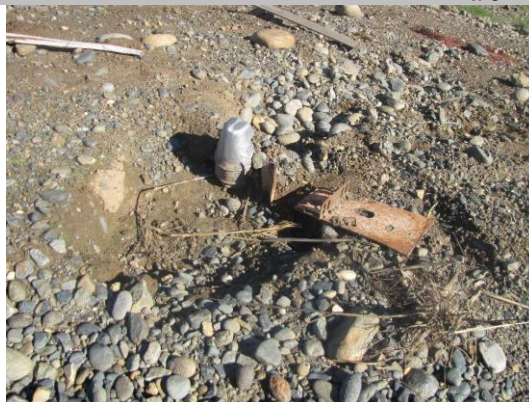
Photo 3 of 3 : UCIP_SP_2017_48007_65921.jpg

Photo 1 of 2. View of localized erosion at air vent located on WS shoulder.

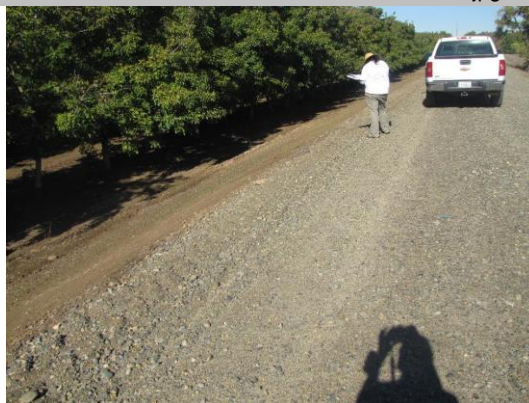
Photo 2 of 3 : UCIP_SP_2017_47874_65937.jpg

View of LS and levee crown looking upstream at crossing. Staff is standing adjacent to cavity located on LS shoulder.

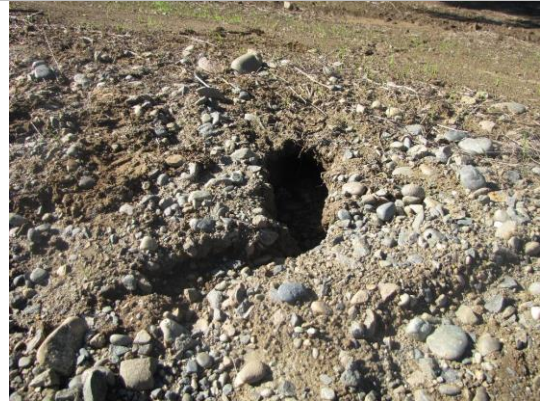
Photo 3 of 3 : UCIP_SP_2017_47874_65935.jpg

View of cavity collapse along assumed pipe alignment located on LS shoulder.

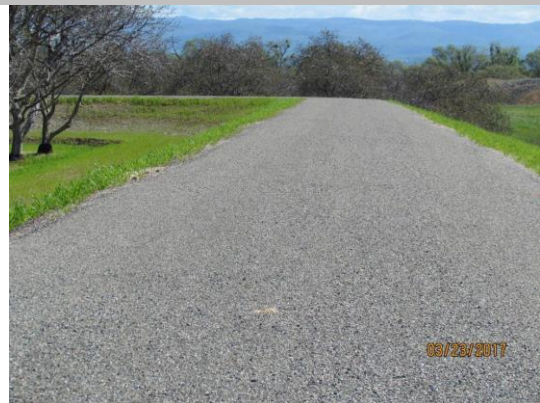
Photo 1 of 2 : SP_2017_MA0007_200_47_20170327_00126.jpg

View of the portion of levee that has been degraded and is being brought back to design elevation and rocked looking upstream. Spring 2017.

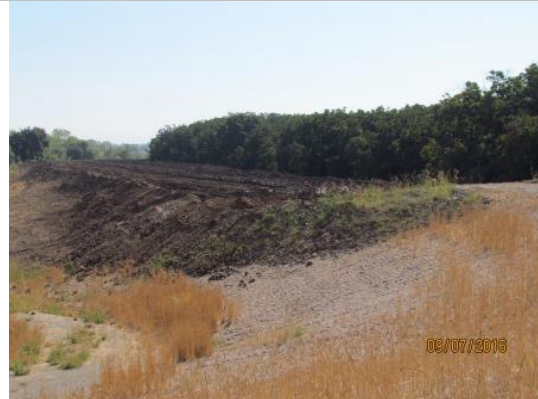
Photo 2 of 2 : SP_2017_MA0007_200_47_20170316_00007.jpg

View of the portion of levee that is currently under construction that has been degraded and is being brought back to design elevation. Fall 2016.

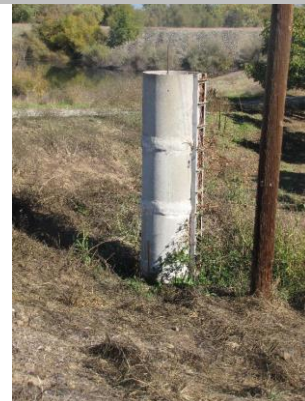
Photo 1 of 3 : UCIP_SP_2017_47989_65939.jpg

WS view of concrete standpipe with blackberry shrubs preventing access to latter.

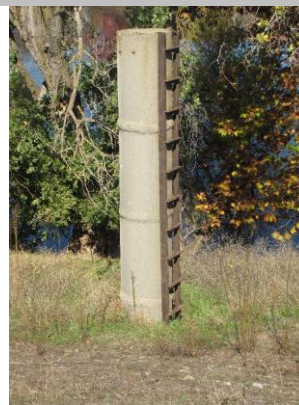
Photo 3 of 3 : UCIP_SP_2017_47990_65944.jpg

View of concrete standpipe located at WS toe. Slide gate inside riser is buried with trash.

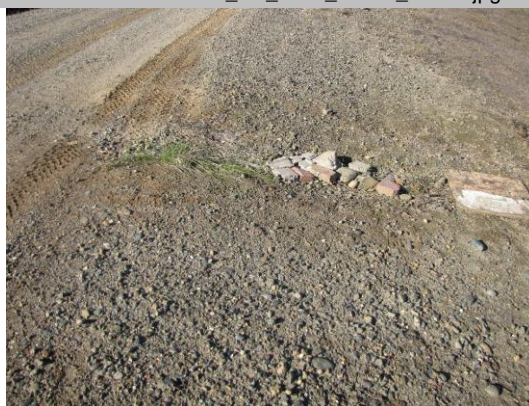
Photo 3 of 3 : UCIP_SP_2017_47878_65951.jpg

WS shoulder with a low point along filled with rocks and brick pieces with what appears to be crossing alignment.

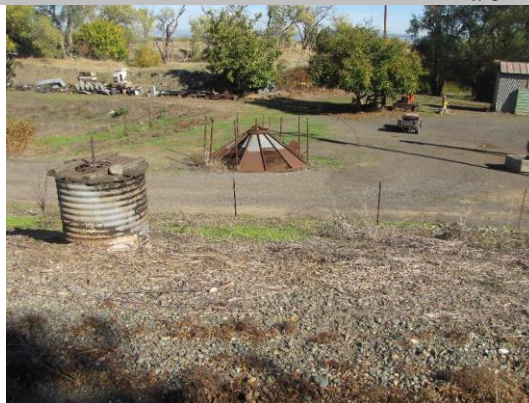
Photo 3 of 3 : UCIP_SP_2017_47997_66000.jpg

View of WS with unknown structure along pipe alignment and pump located over 100 feet from WS toe.
